Report Number **BTC 11603F**

A FIRE RESISTANCE TEST ON A LOADBEARING
KINGSPAN TEK HAUS™ BUILDING SYSTEM
CONDUCTED IN ACCORDANCE WITH
BS 476: PART21: 1987: CLAUSE 8.

Test Date: 10th July 2001

Customer: Kingspan Insulation Limited
Pembridge
Leominster
Herefordshire
HR6 9LA

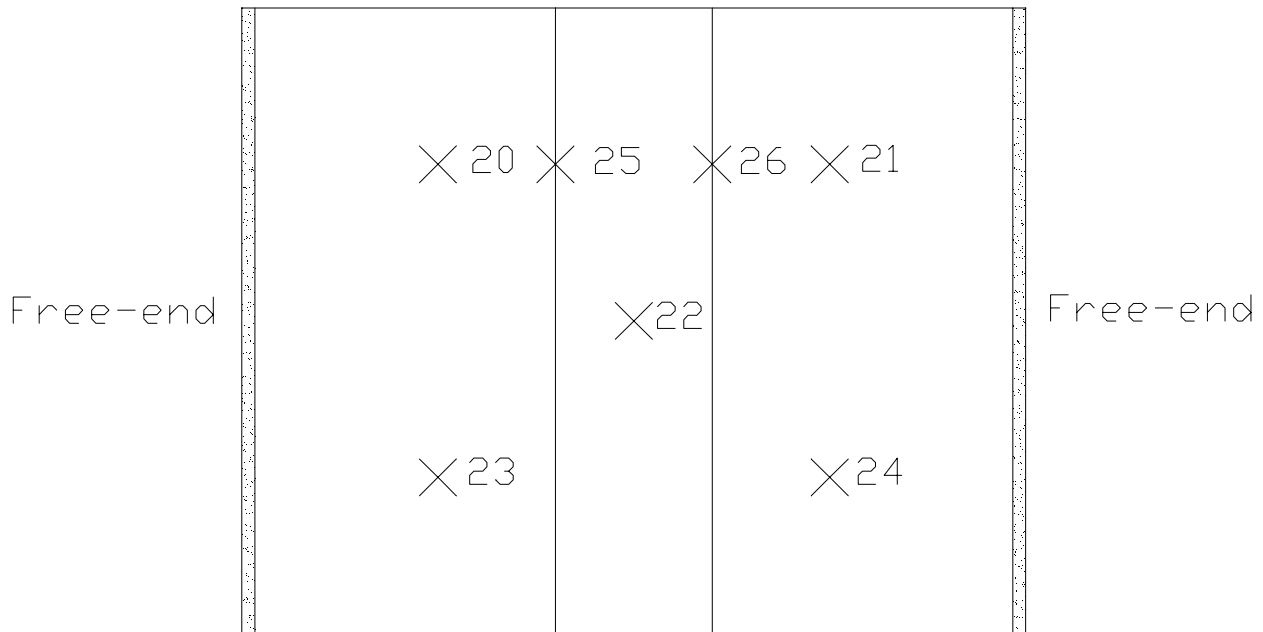
Figure 7. Unexposed face thermocouple layout.

Time (mins)	Temperature Rise (°C)				
	Thermocouple No. 20	Thermocouple No. 21	Thermocouple No. 22	Thermocouple No. 23	Thermocouple No. 24
71	13	26	2	77	1
72	47	39	2	77	1
73	68	47	3	78	1

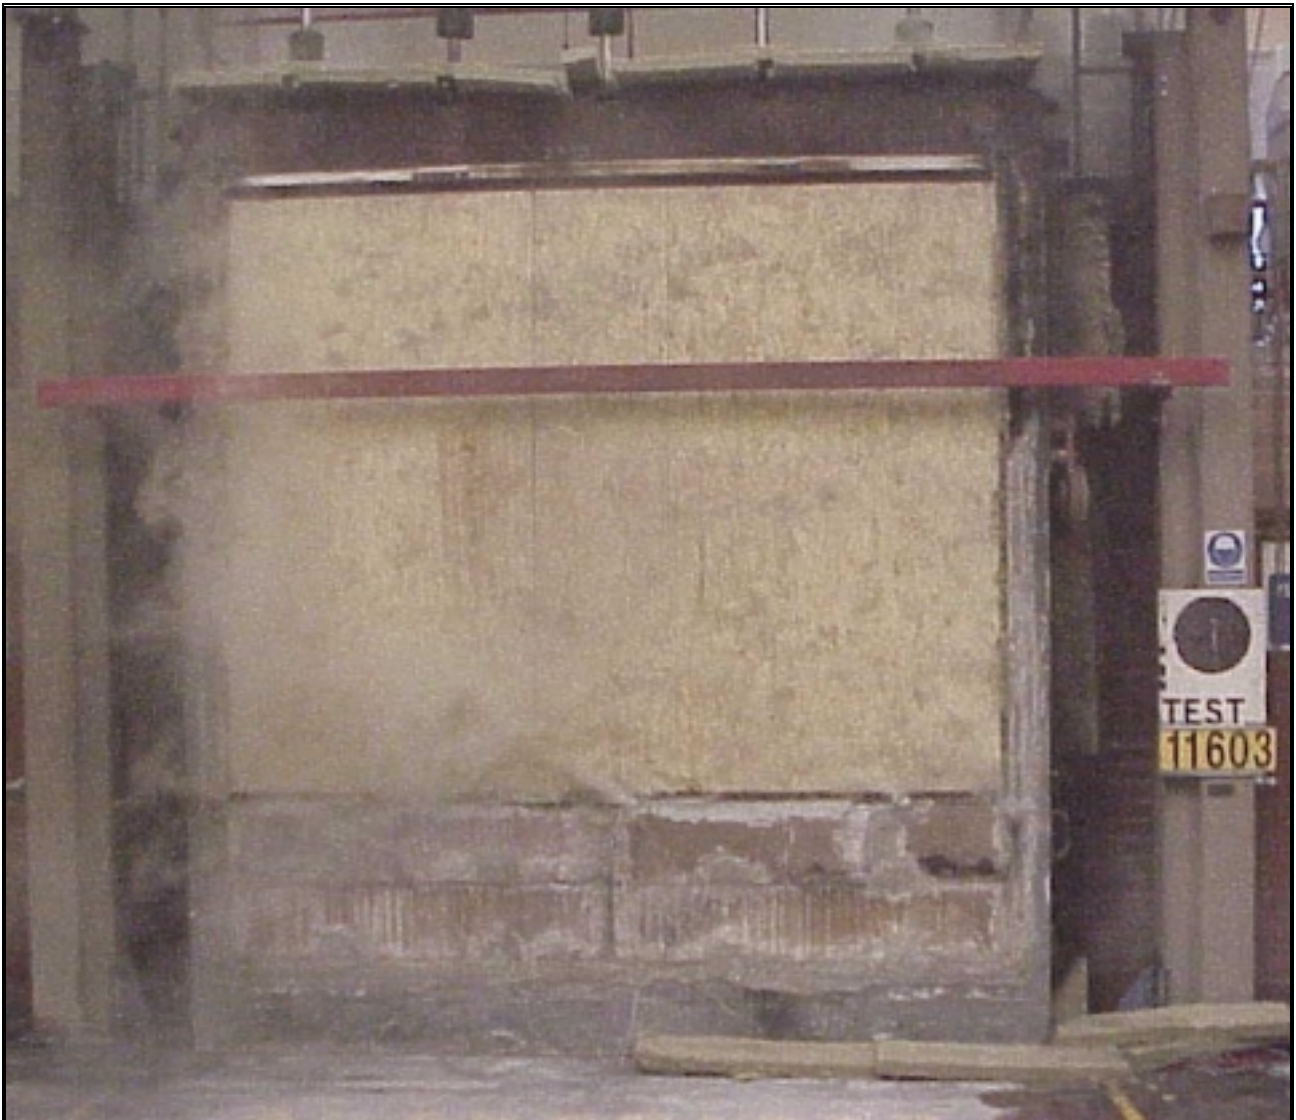
Time		<i>Observations</i>
hrs	mins	
		All observations refer to the exposed face unless otherwise stated.
	47	Exposed face observations no longer possible due to view ports being complete blacked out.
1	02	<i>Unexposed face</i> Deflection transducer was removed.
1	08	<i>Unexposed face</i> Smoke was being emitted from the bottom of the specimen.
1	12	TEST TERMINATED at the request of the laboratory.

Photo 3. Smoke being emitted from the bottom of the specimen.

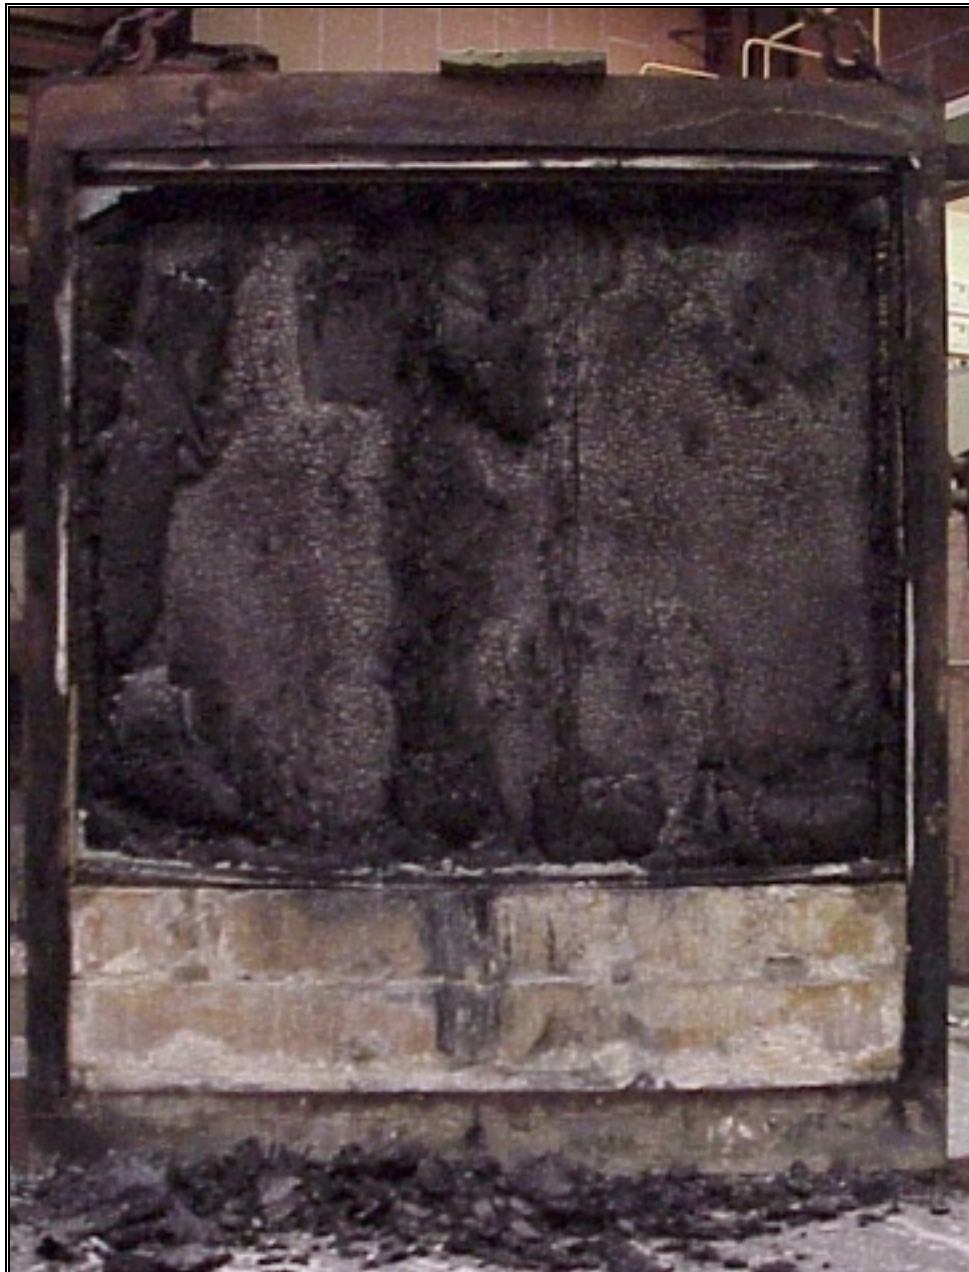
Time		<i>Observations</i>
hrs	mins	
		All observations refer to the exposed face unless otherwise stated.
	0	Test Started.
	17	The joints of the plasterboard were still sealed.
	18	The joints had opened approximately to 1-2mm.
	25	The left-hand joint had opened approximately to 1-2mm. The right-hand joint had opened approximately to 4-5mm.
	30	The left-hand joint had opened approximately to 3-4mm. The right-hand joint had opened approximately to 6-8mm.
	32	A vertical crack had developed at the top on the right-hand side of the centreboard approximately 300mm long. The right-hand side of the centreboard had cracked adjacent to the right-hand vertical joint.
	33	A vertical crack had developed at the bottom right-hand side of the centreboard, approximately 150mm long. Left-hand joint open to approximately 6mm. Right-hand joint open to approximately 15mm.
	37	There was flaming and turbulence in the furnace

40	Visibility was poor due to the turbulence in the furnace. The right-hand joint had opened approximately to 20mm and the left-hand joint had opened approximately to 8mm.
	44	The plasterboards remained intact.

Photo 4. Exposed face after the test.
